#### Weston Solutions, Inc.

REMOVAL SUPPORT TEAM 3 EPA CONTRACT EP-S2-14-01

May 5, 2016

SUBJECT: STRUCTURAL EVALUATION - NIAGARA FALLS BOULEVARD SITE

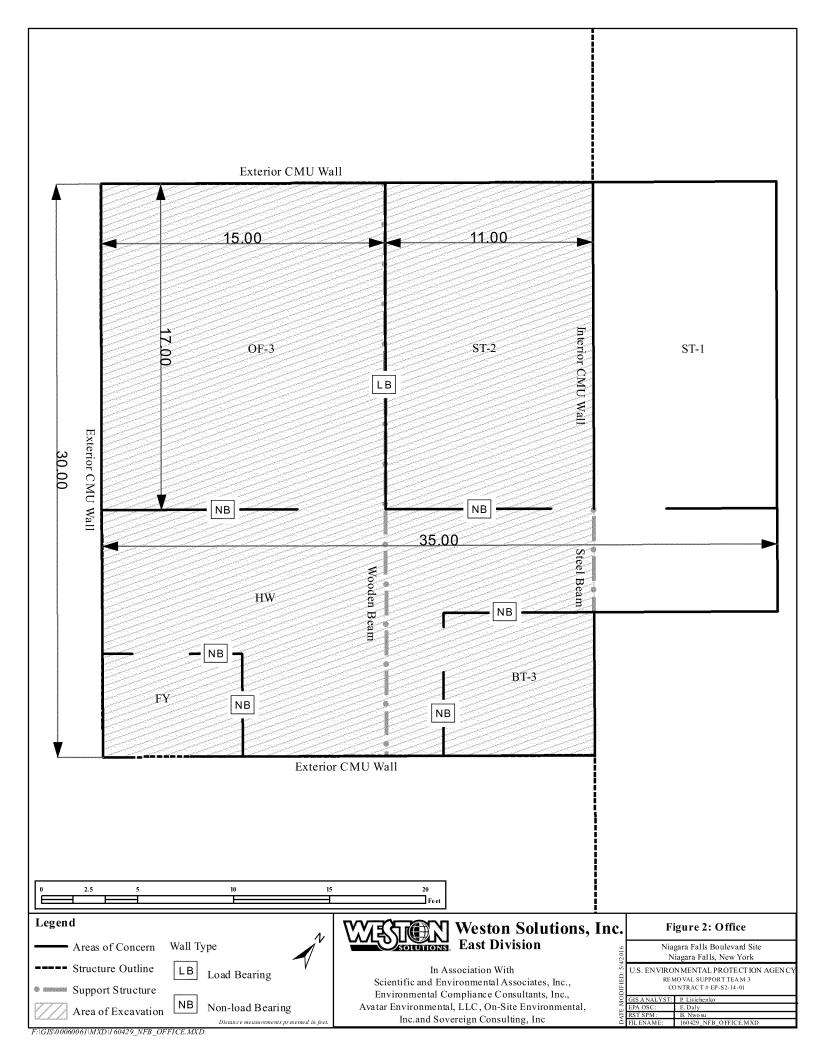
### Office Area (see attached Figure 2)

Walls marked NB: Non-bearing, wood-framed interior walls that bear directly on the top of the floor slab. These walls can be removed.

Walls marked LB: Load-bearing, wood-framed interior wall that bears directly on the top of the floor slab. This wall supports the roof joists spanning in the E-W direction. Roof joists need to be shored prior to removing wall. Wall to be removed in sections to access slab and soils below the wall and new footing installed prior to moving on to another section of wall.

The exterior north, west, and south walls and the interior (former exterior) east wall are all CMU (concrete masonry units) walls. The bottom of these wall footings should be approximately 3'-6" below top of floor slab. Removal of the floor slab will not affect the these walls.

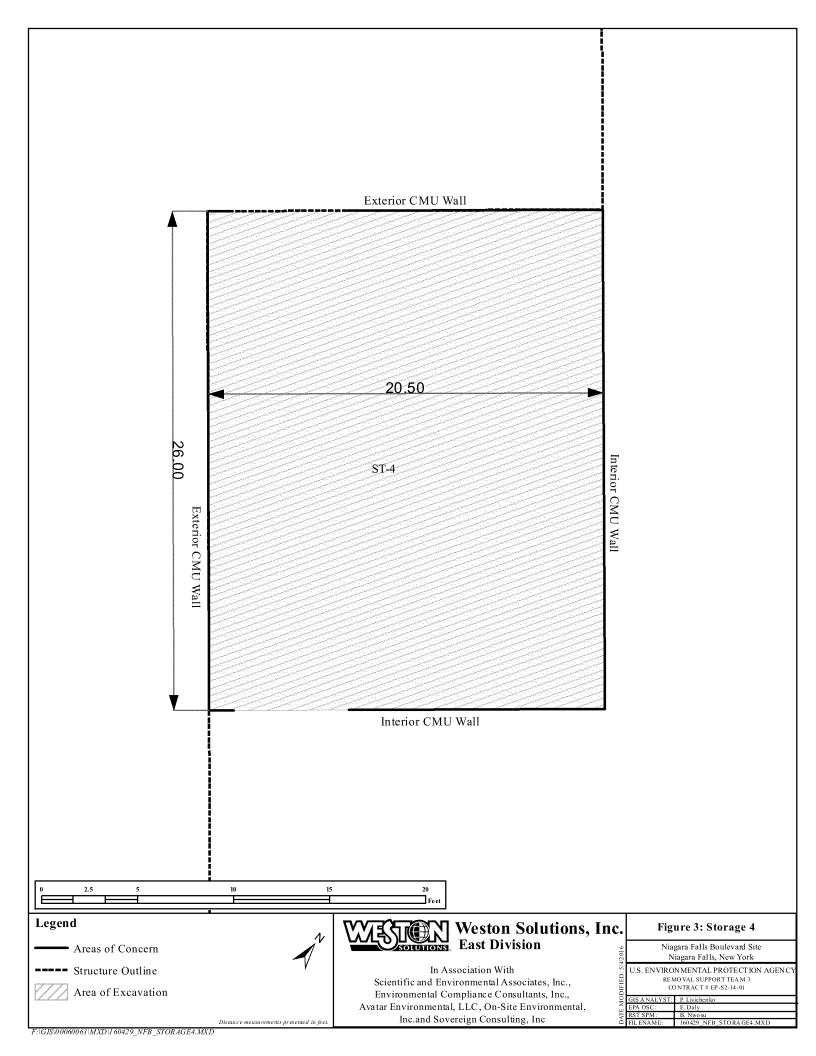
# Storage 4 Area (see attached Figure 3)

The exterior north and west walls and the interior (former exterior) south and east walls are all CMU walls. The bottom of these wall footings shoul d be approximately 3'-6" below the top of the floor slab. Removal of the floor slab will not affect these walls.

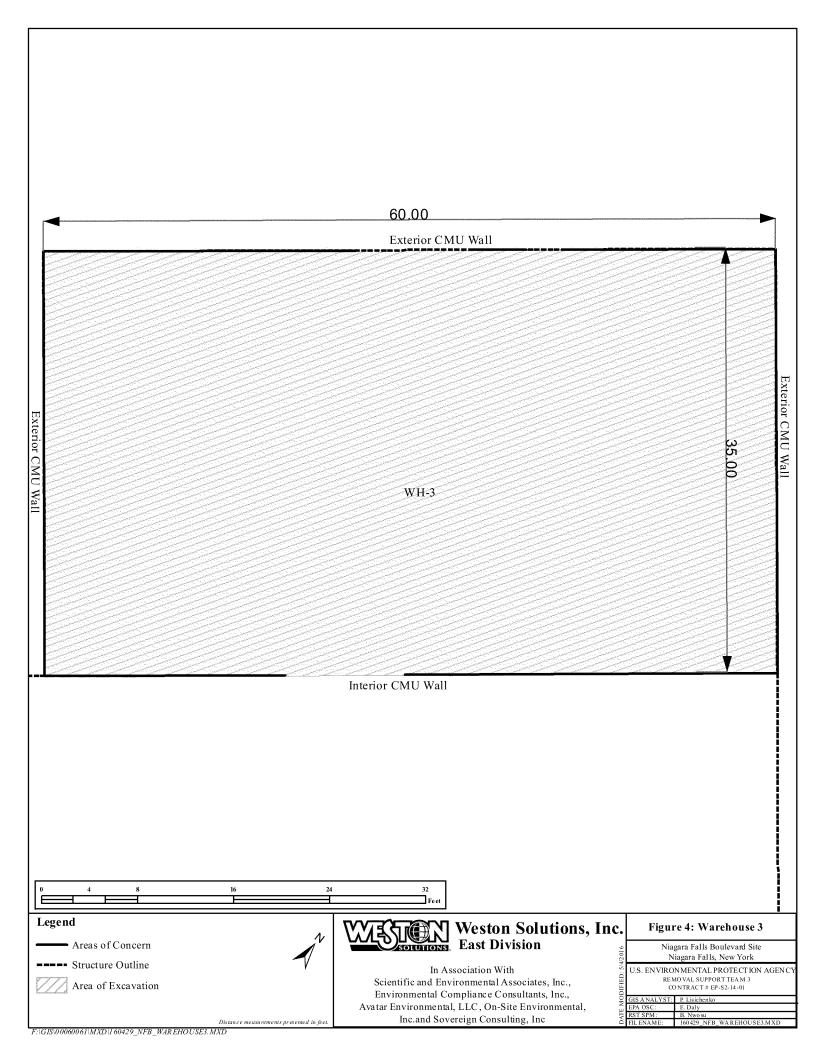
# Warehouse 3 Area (see attached Figure 4)

The exterior north, east, and west walls and the in terior (former exterior) south wall are all CMU walls. The bottom of these wall footings should be approximately 3'-6" below the top of the floor slab. Removal of the floor slab will not affect these walls.
